BUREAU OF SHIPS GROUP  
TECHNICAL INSPECTION REPORT

⑥ OPERATION CROSSROADS.  
U.S.S NEVADA (BB36).

TEST ABLE.

VOLUME I [redacted] [u] 8

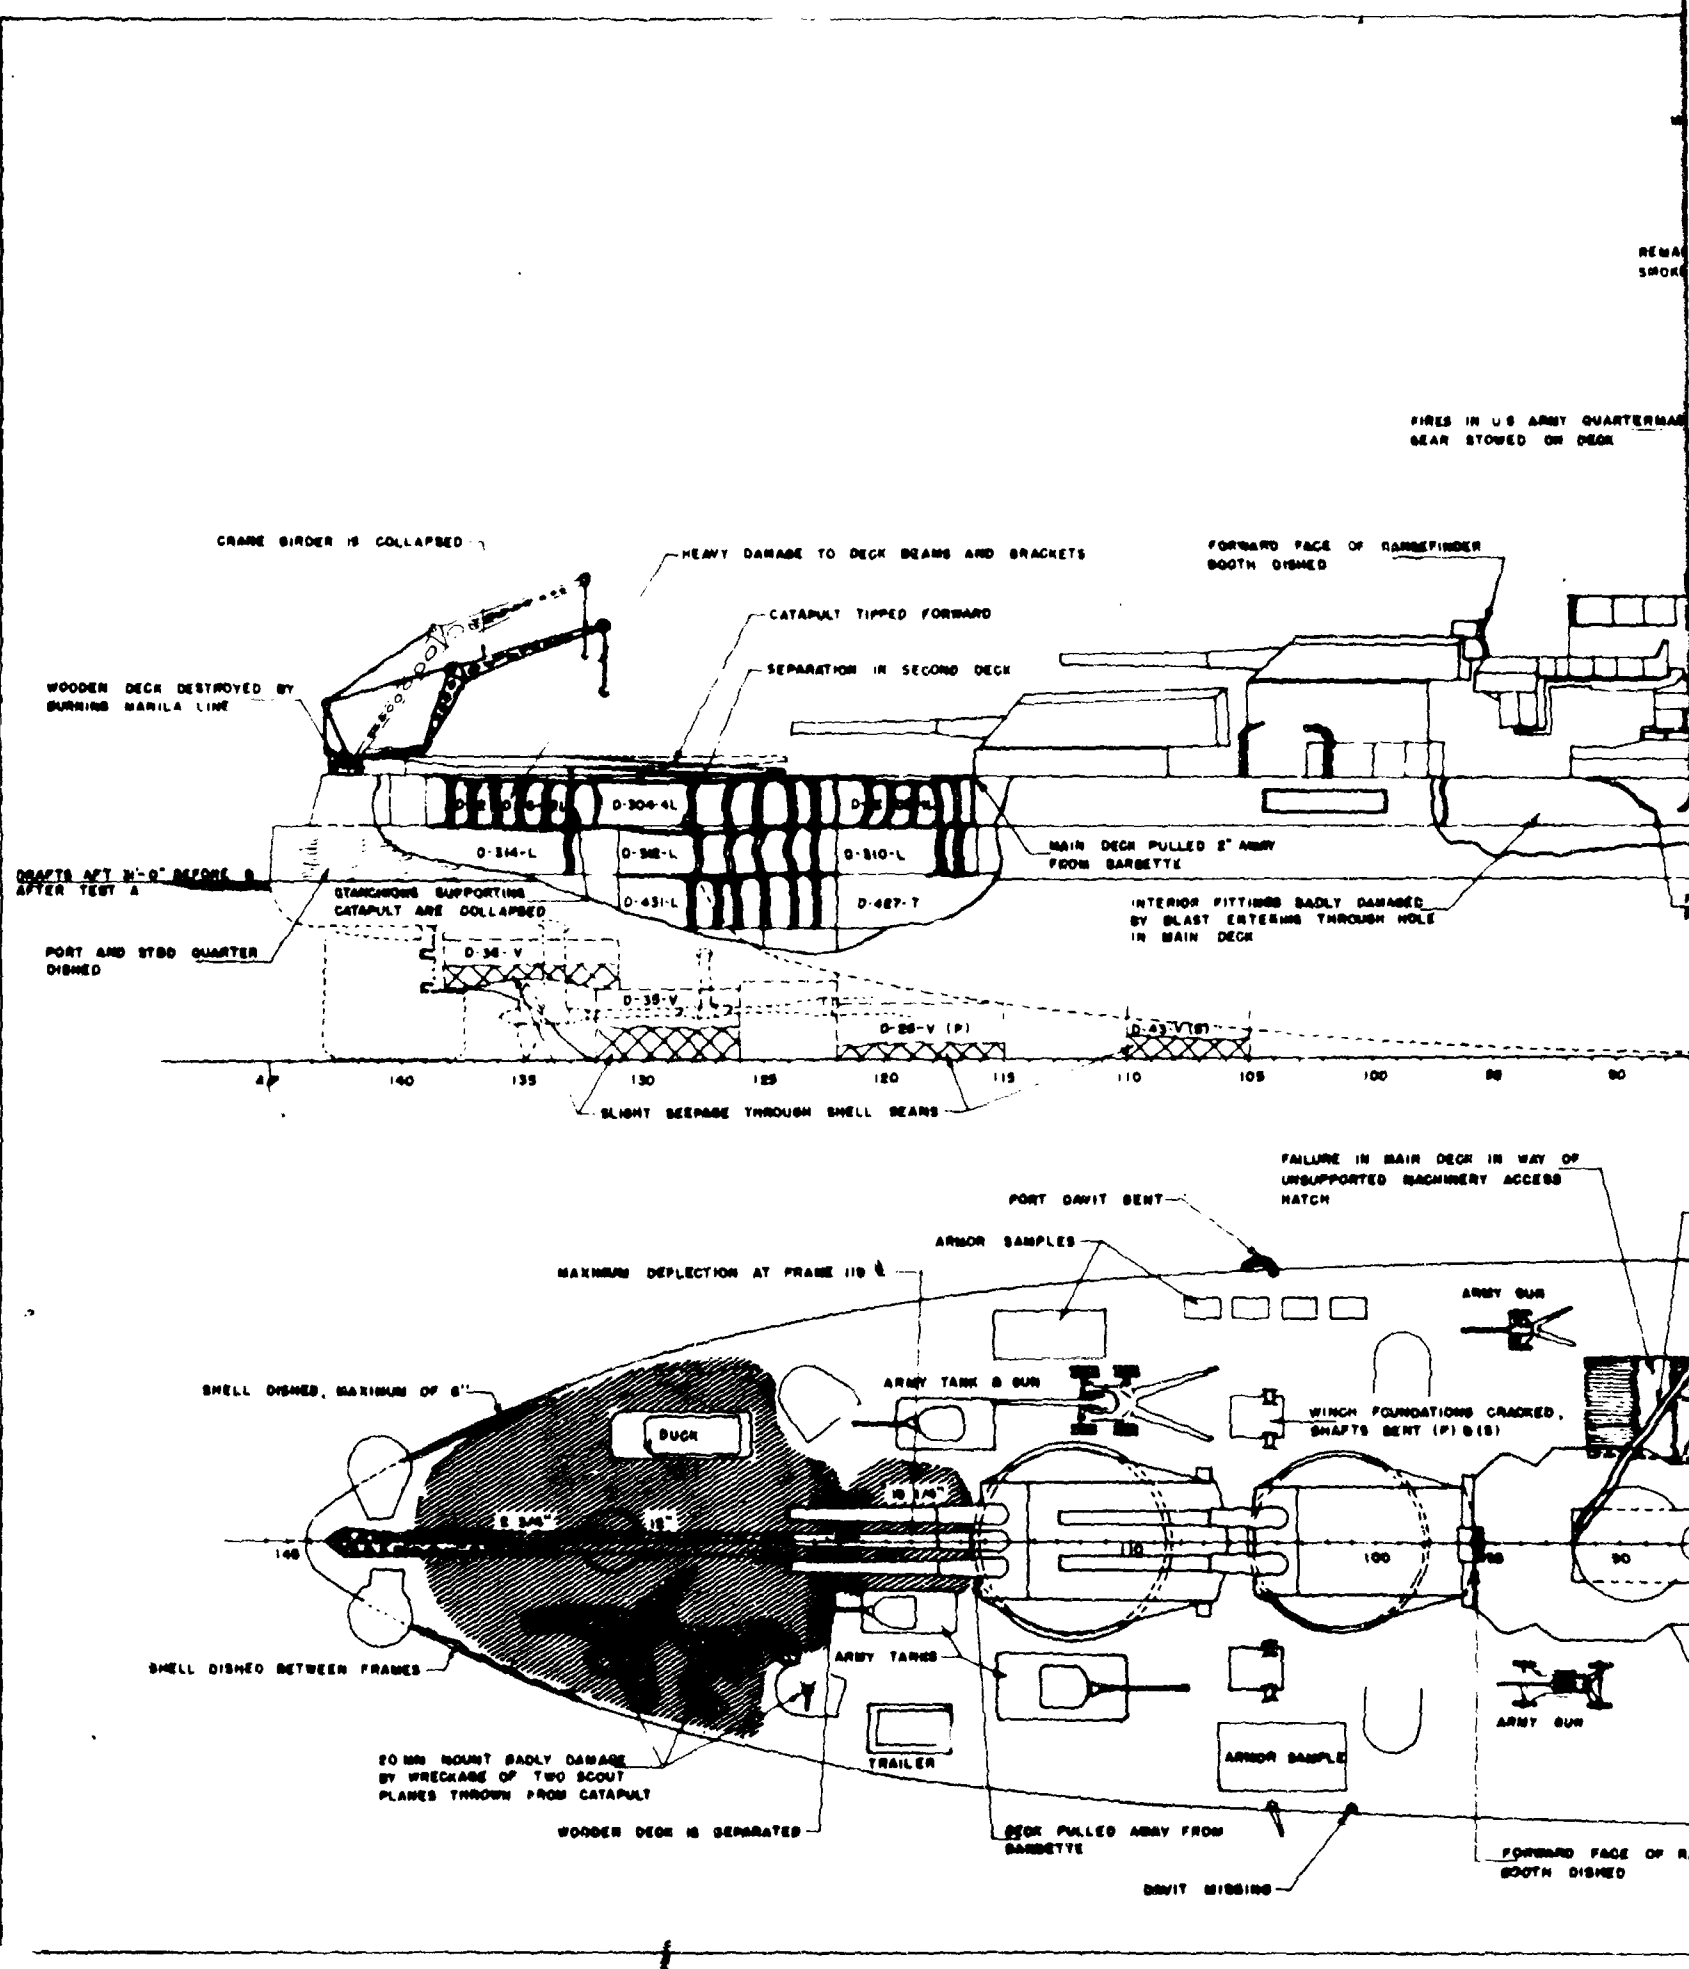
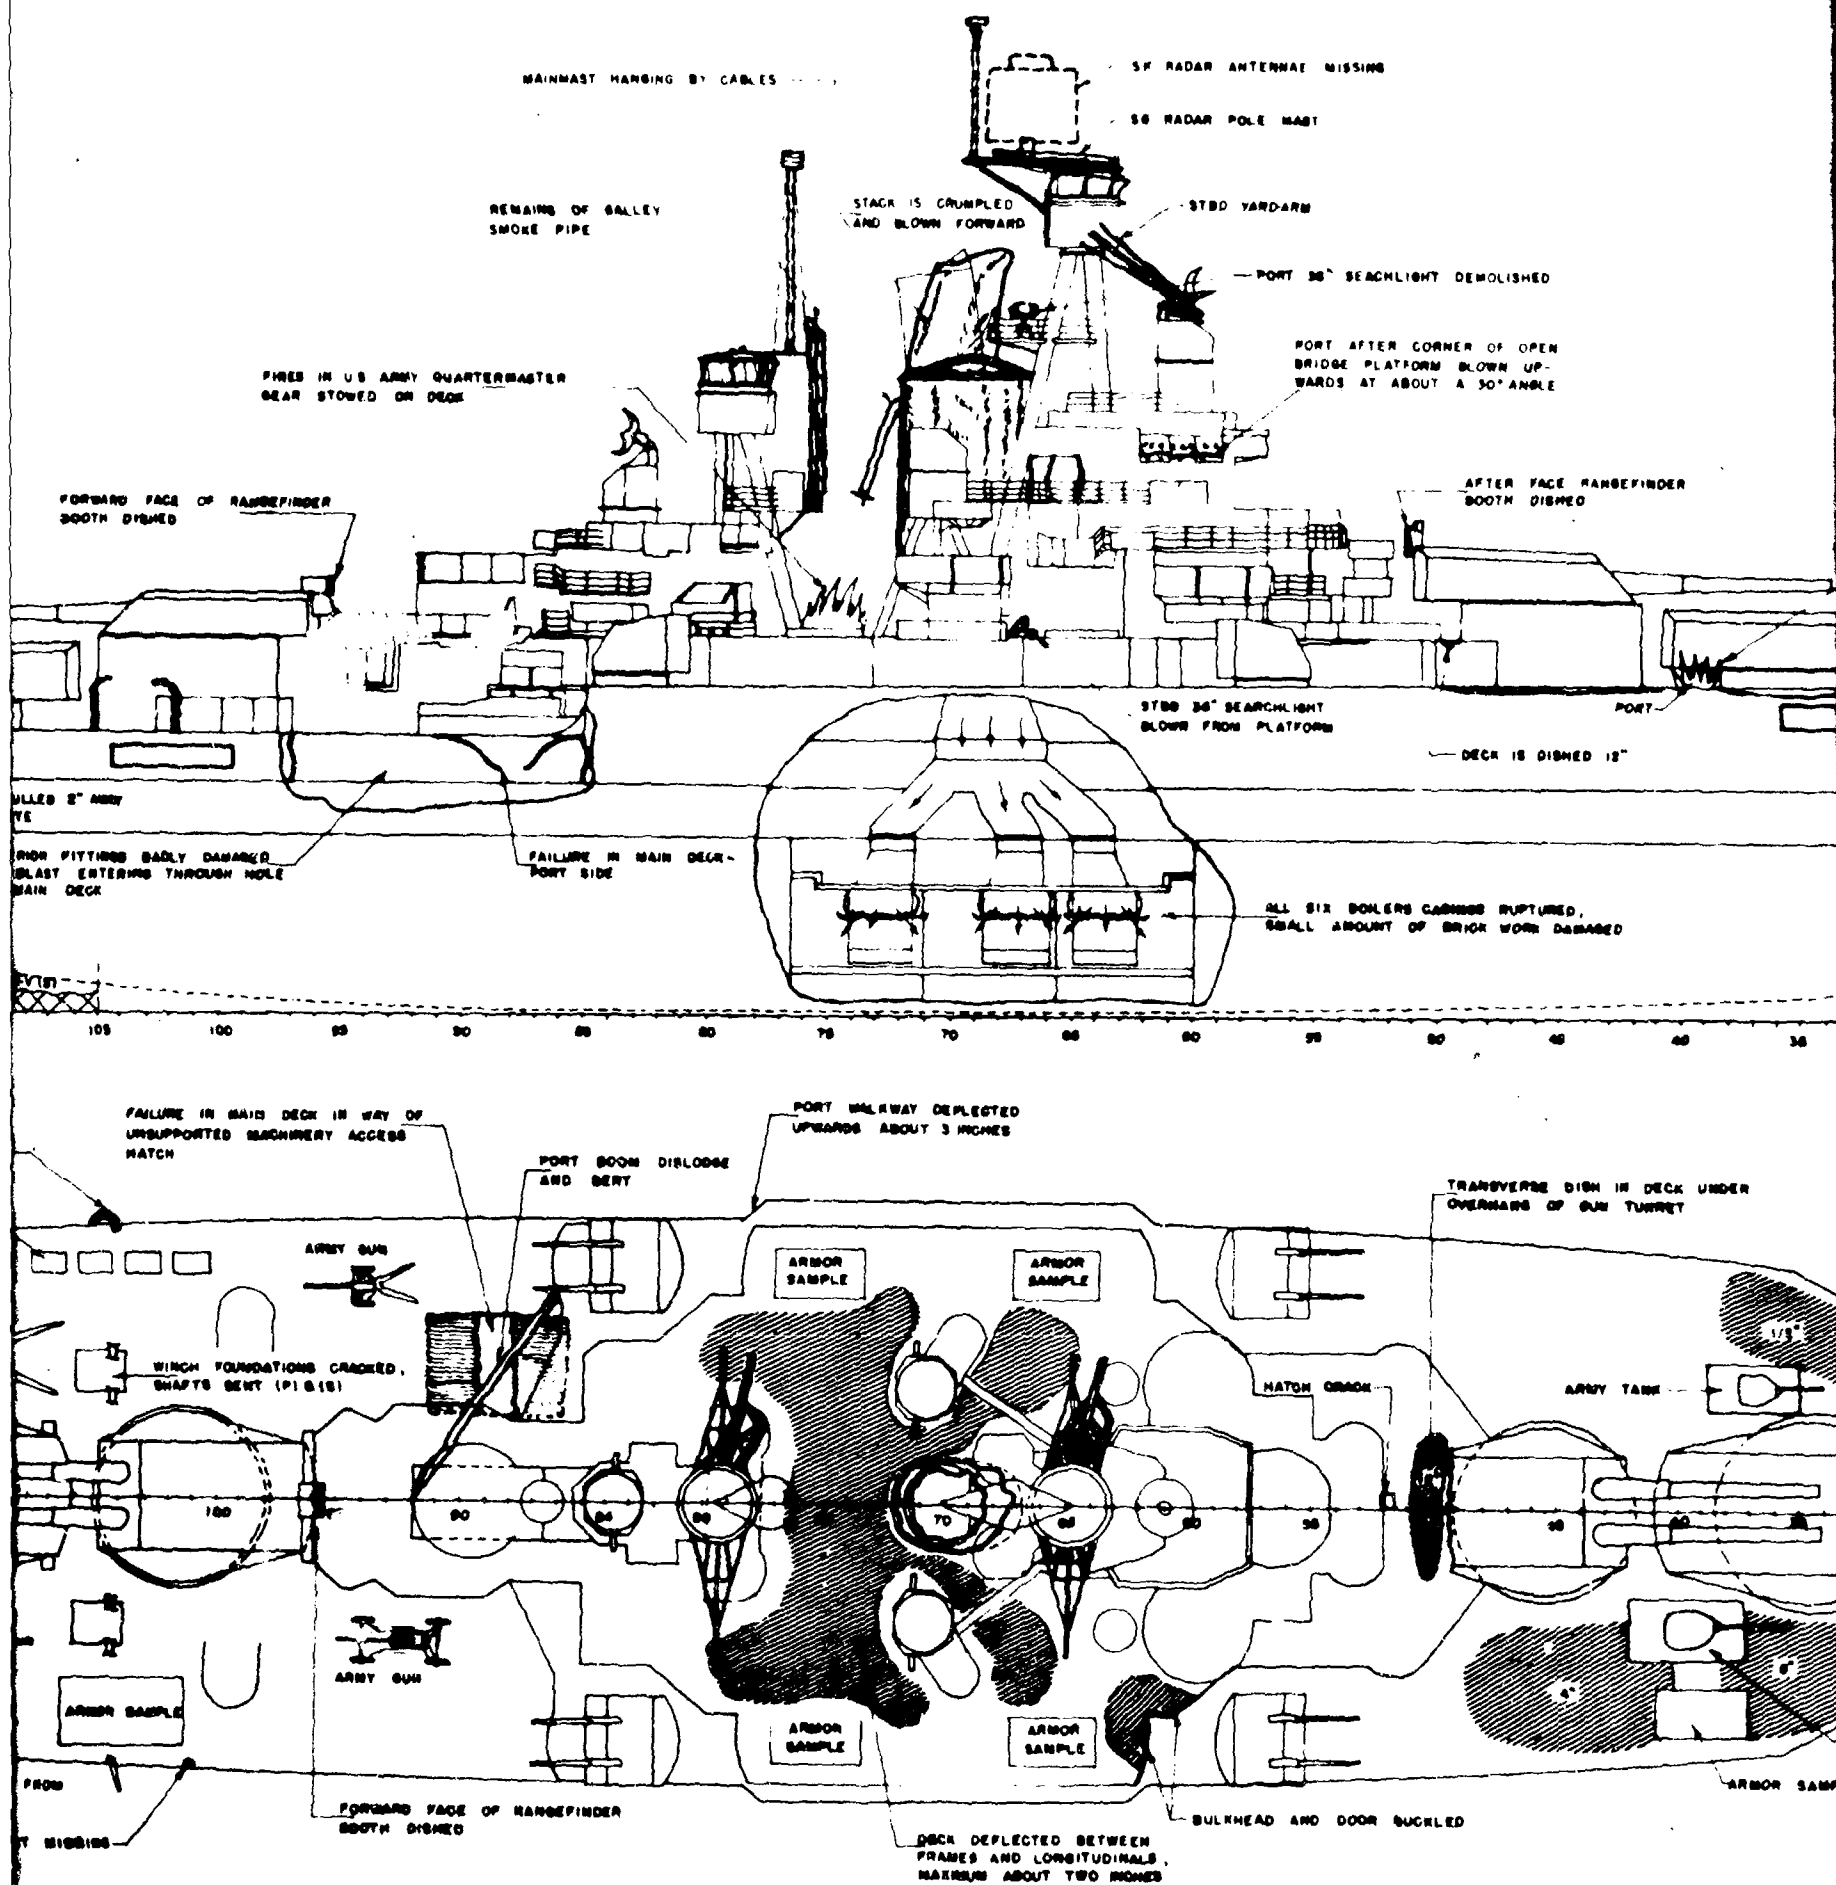
The weather deck aft of No. 4 turret and the port side from frame 86 to 91, is badly damaged. Forward of frame 60, the deck is lightly damaged. All exposed portions of the superstructure have suffered varying degrees of damage (see figure 1, page 91 ).

MISSING

5" SEARCHLIGHT DEMOLISHED

AT AFTER CORNER OF OPEN  
DECK PLATFORM BLOWN UP-  
RODS AT ABOUT A 30° ANGLE

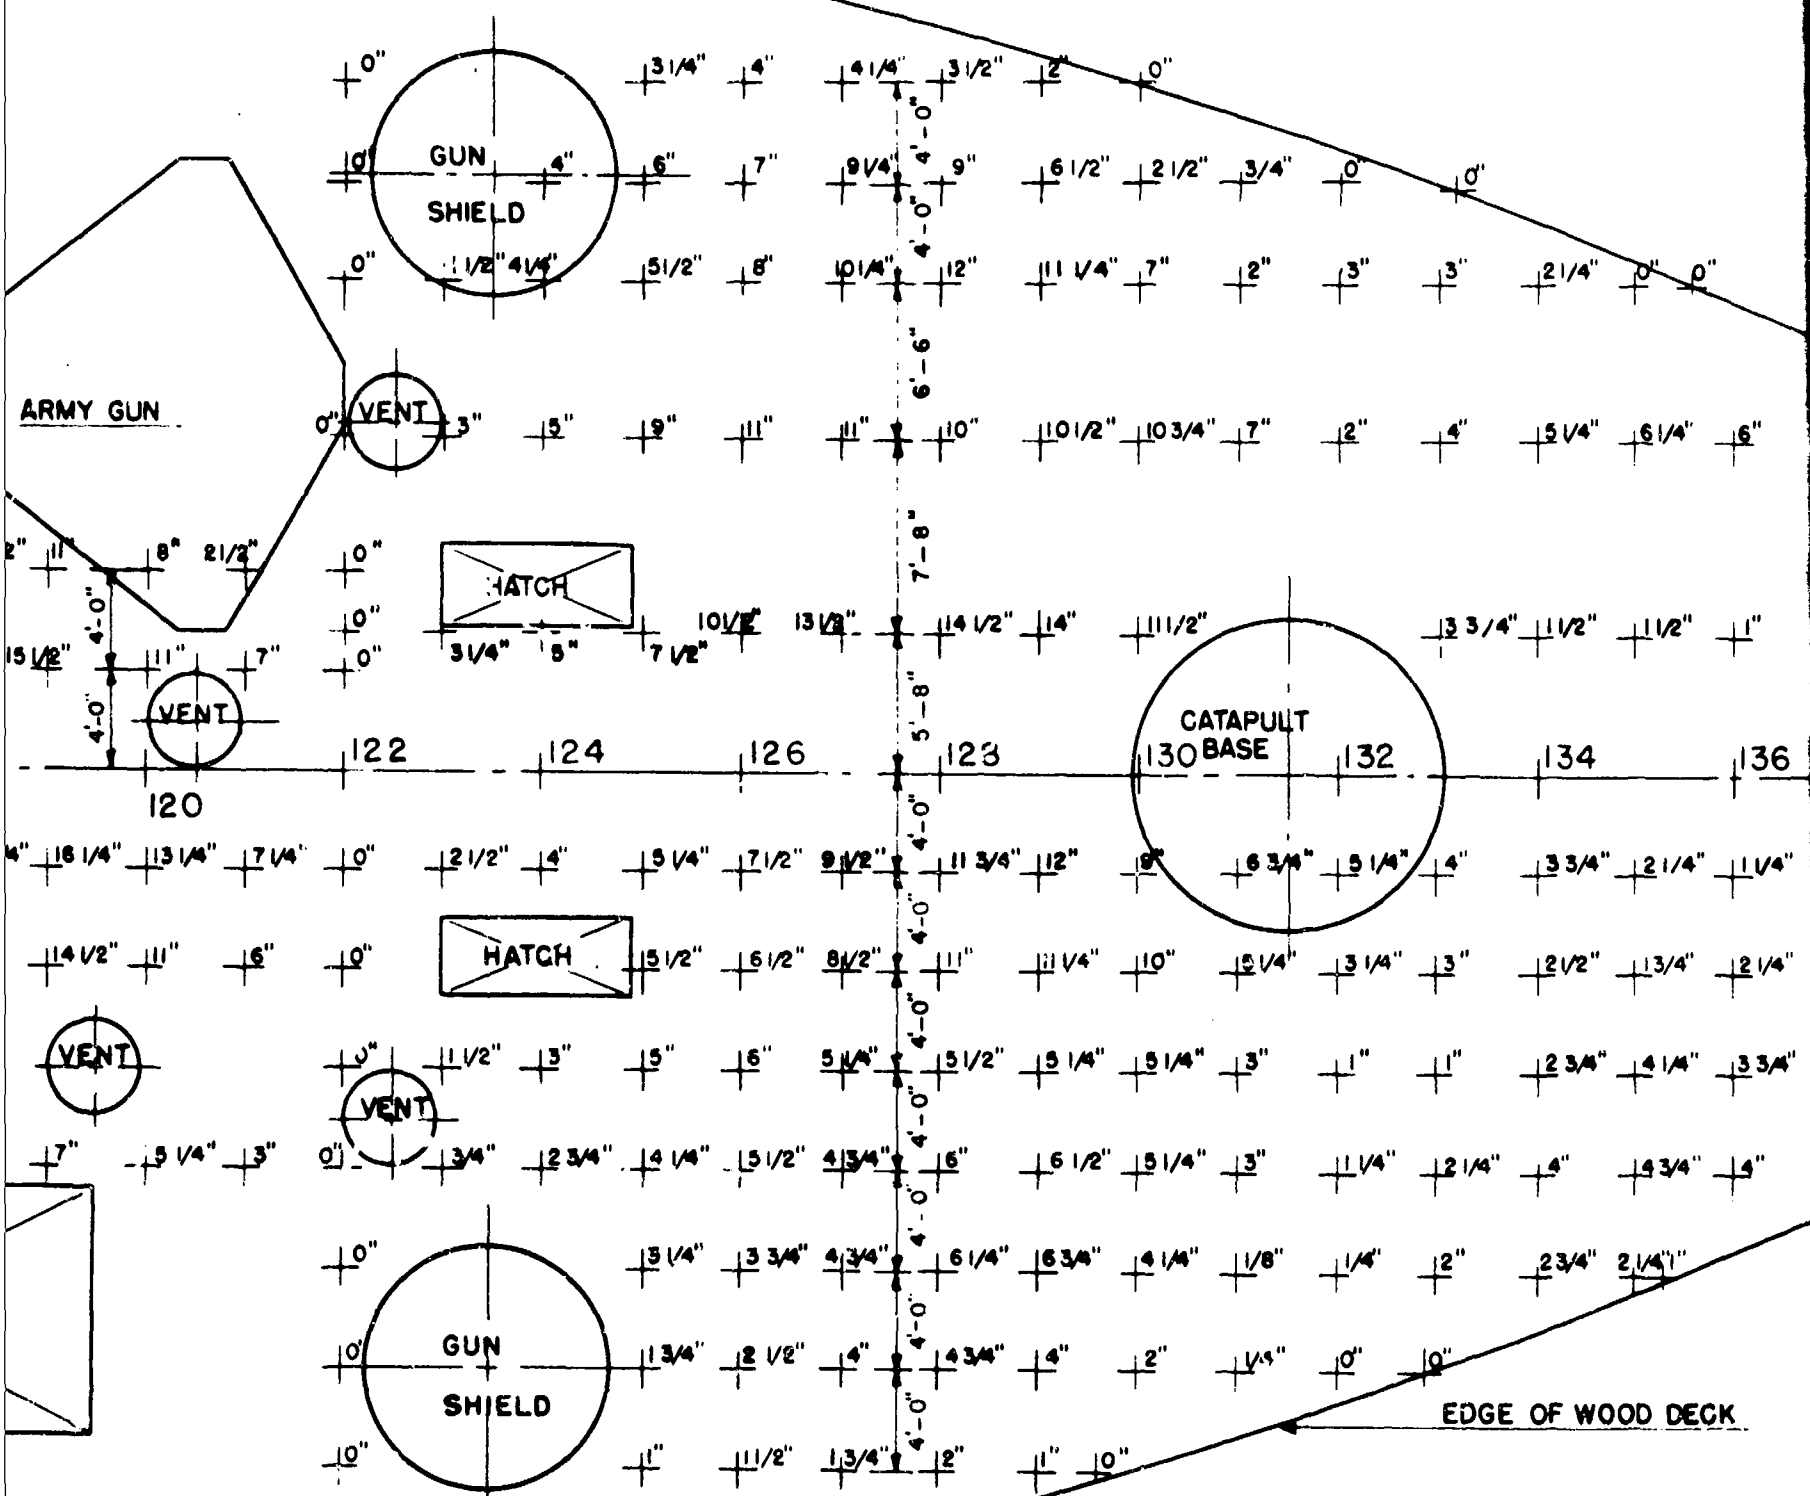
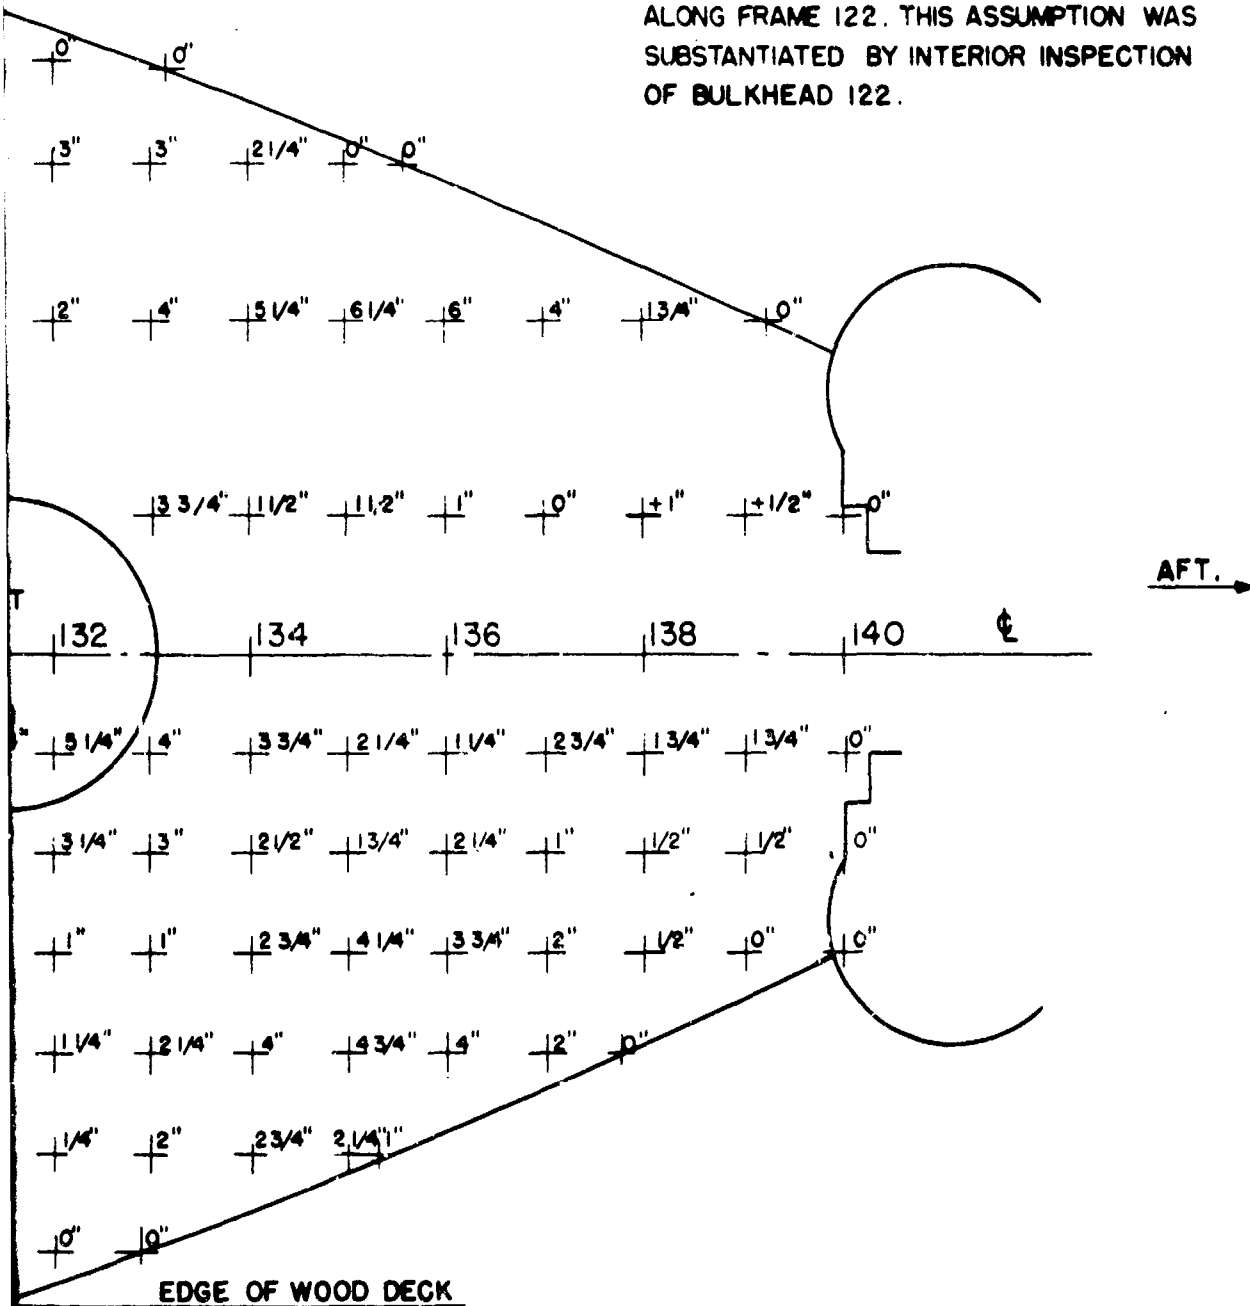
FIGURE NO. 2

There is heavy deflection of the main deck aft as a result of blast. The most severe depression is slightly aft of No. 4 turret (figures 1 and 2, pages 94 and 99). This depression pulled the deck away from the after face of No. 4 barrette. The maximum deflection in this area is about 16 1/2 inches. Between frames 122 and 132 the maximum deflection is about 14 inches. The deflections of the main deck are accompanied by failure of supporting stanchions and distortion of connections of the deck beams to the shell stiffeners. The second deck is deflected aft of the armor from bulkhead 122 to about frame 134, the maximum being about 12 inches. The damage diminishes as it goes deeper into the ship.

FOR THE PURPOSE OF OBTAINING THESE MEASUREMENT IT WAS NECESSARY TO ASSUME THAT THE DECK DID NOT DEFLECT ALONG FRAME 122. THIS ASSUMPTION WAS SUBSTANTIATED BY INTERIOR INSPECTION OF BULKHEAD 122.

The camber of weather decks should be increased. End connections of stanchions should be designed to allow the columns to buckle at their critical load without tripping the flange of the deck beams which they support. Additional recommendations pertinent to topside structure are listed in Part C, Item B, sub-item (e), of this report.
